## Ringling Bros. Snake Den No. 20

## Circus Model Builders

Drawn By  
Charles L. Shaffer

#0279

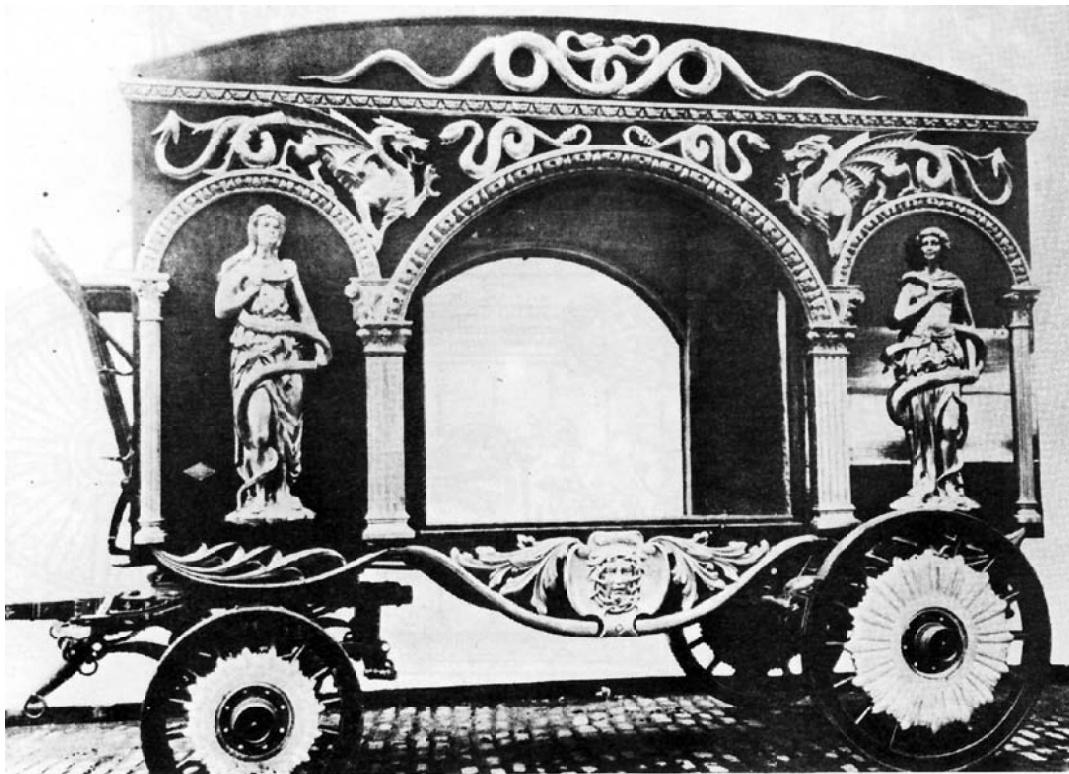
This photo shows the snake den before being shipped to the Ringling Bros. at Baraboo in 1903. The wagon was photographed at the Bode Wagon Works. Snakes, dragons, snake charmers, and a Medusa's head decorate the sides of the wagon. [The photo is from the R.E. Conover collection.]

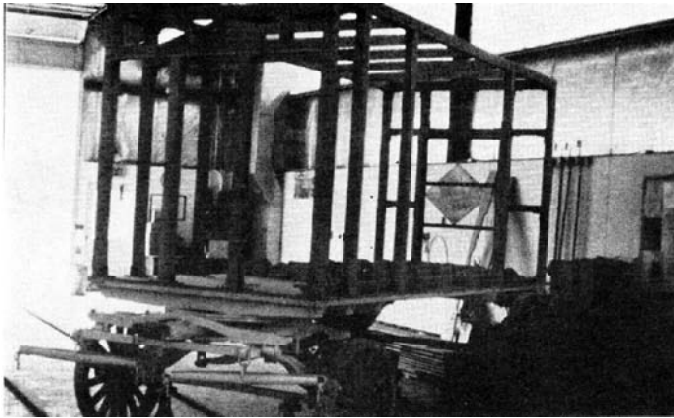
View of the wagon frame taken during rebuilding. [Chuck Meltzer photo]

Bill Thalmeyer was commissioned to recreate the missing carvings and, in 1973 and 1974, work progressed on the wagon itself. The project was completed in early 1975 and Ringling Bros. Snake Den No. 20, in all its original gild and ornate splendor, may be seen at the Circus World Museum.

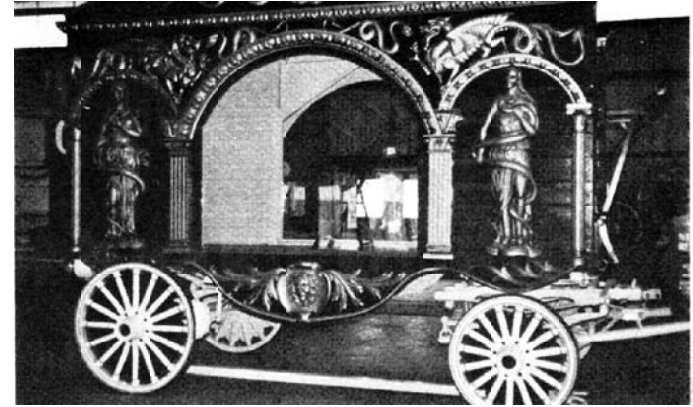
Side View of restored snake den taken at the Circus World Museum

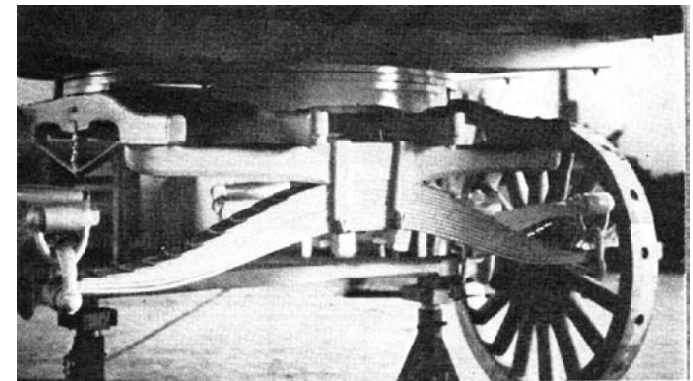
View of front undercarriage taken during restoration. [Chuck Meltzer photo]

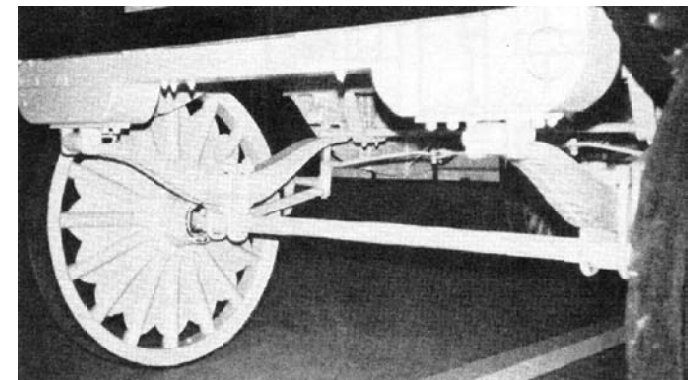
View of rear undercarriage.
